**RECONSTRUCTING THE ASSEMBLAGE OF IRON ARTIFACTS FROM THE  
LATE HELLENISTIC SHIPWRECK AT KIZILBURUN, TURKEY**

A Thesis

Submitted to the Office of Graduate Studies of  
Texas A&M University  
in partial fulfillment of the requirements for the degree of

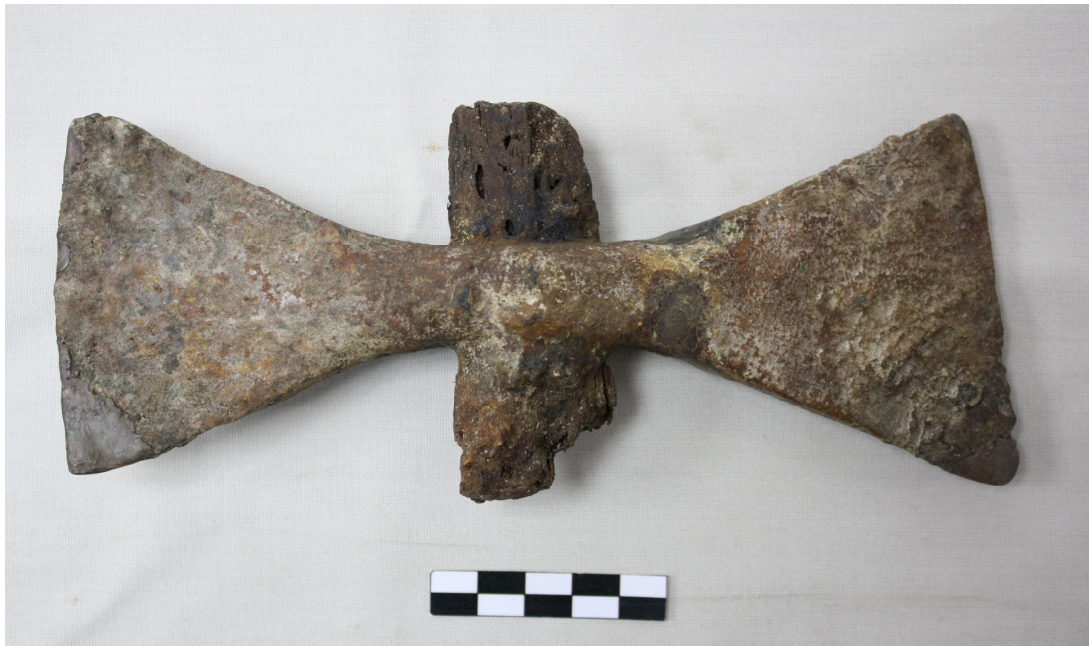
Fig. 3.14: **AX 2** after undergoing conservation for the handle.

Mechanical cleaning proceeded normally, but it was quickly ascertained that a portion of the handle remained intact and would need to be addressed. Being that the axe handle had been so heavily impregnated with iron salts during the corrosion of the metallic blade, sucrose was deemed to be an appropriate treatment for the wood. The cast was placed in five liters of reverse osmosis water along with 0.1% Kathon, a biocide that discourages fungal or bacterial growth during the course of treatment. A 0.2% increment of sugar was added every day for four days, until it was decided that a larger increment would be desirable in order to speed treatment. The solution was then increased by increments of 2% for 14 days until the solution, measured using a refractometer, reached a concentration of 20%. After 14 days, additions were made at a 4% daily increment until the concentration reached a saturation of 70%. The axe was allowed to sit for an additional six months in the solution until it was removed for slow, controlled drying. It was placed in a closed container atop stainless steel screening so that the excess sucrose

could drip off, and the axe was periodically turned in order to prevent the sugar from pooling at the surface. After a period of 12 weeks, the sugar had completely crystallized, with no more liquid sugar pooling. The wood was stable, and the axe was removed from the container. No shrinking of the wood was observed.

Attention was turned toward perfecting the cast. There had been some epoxy leaking during casting, so it was necessary to grind down the extra epoxy in order to mimic the surrounding surface. Air bubbles were visible within the cast, and these were filled using more liquid epoxy simply pumped into the imperfections. The new areas as well as the sanded portions were painted to match the natural iron-stained surfaces of the cast, and the object was deemed complete (Fig. 3.14).

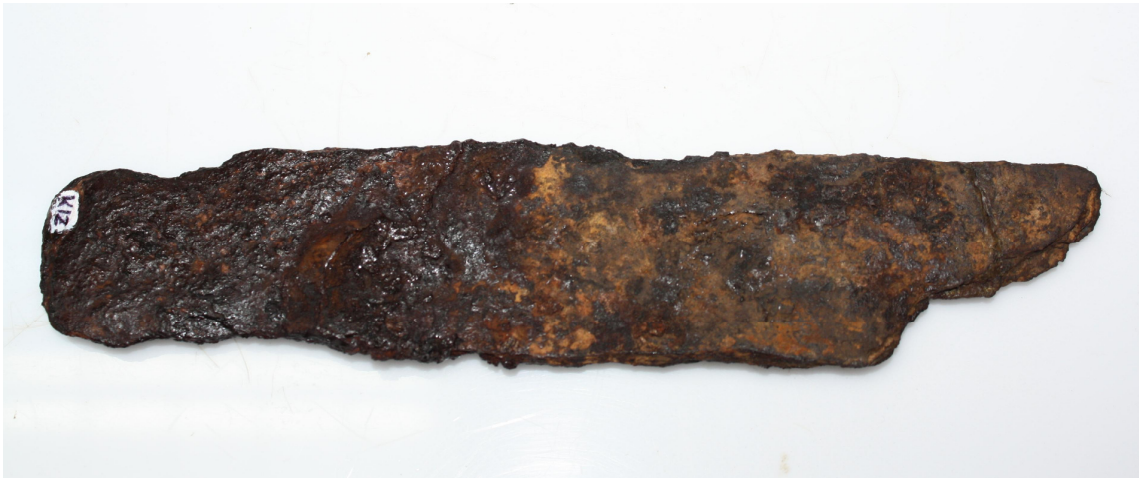
Fig. 3.15: **FB 1** after separation from stock.

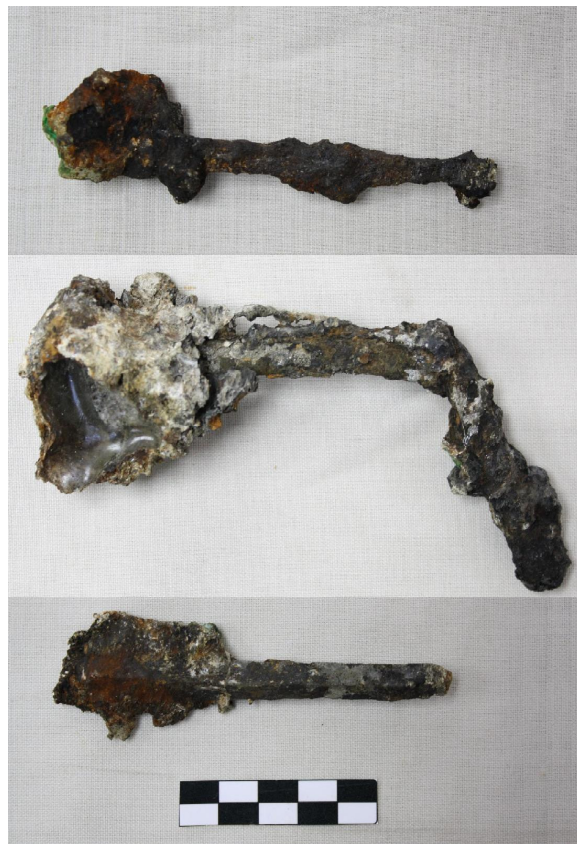
Three iron nails (**FN 1**, **FN 2**, and **FN 3**) are among the objects cast from the wreck, but none has produced a complete set of dimensions. All three nails are roughly square in cross-section and taper toward one end, which can be assumed to be the tip even though none is preserved at the extremity (Fig. 3.17). The three nail concretions were all

broken, so casting involved simply pouring epoxy into the exposed void and letting it harden. **FN 2** had been used, evidenced by the bend or clench in the shaft as well as the wood remains attached to the shaft, while **FN 1** and **FN 3** appear to have been unused. The implications of these finds are discussed further in a separate M.A. thesis analyzing the hull remains.<sup>180</sup>

Fig. 3.17: **FN 1** (top), **FN 2** (middle), and **FN 3** (bottom).

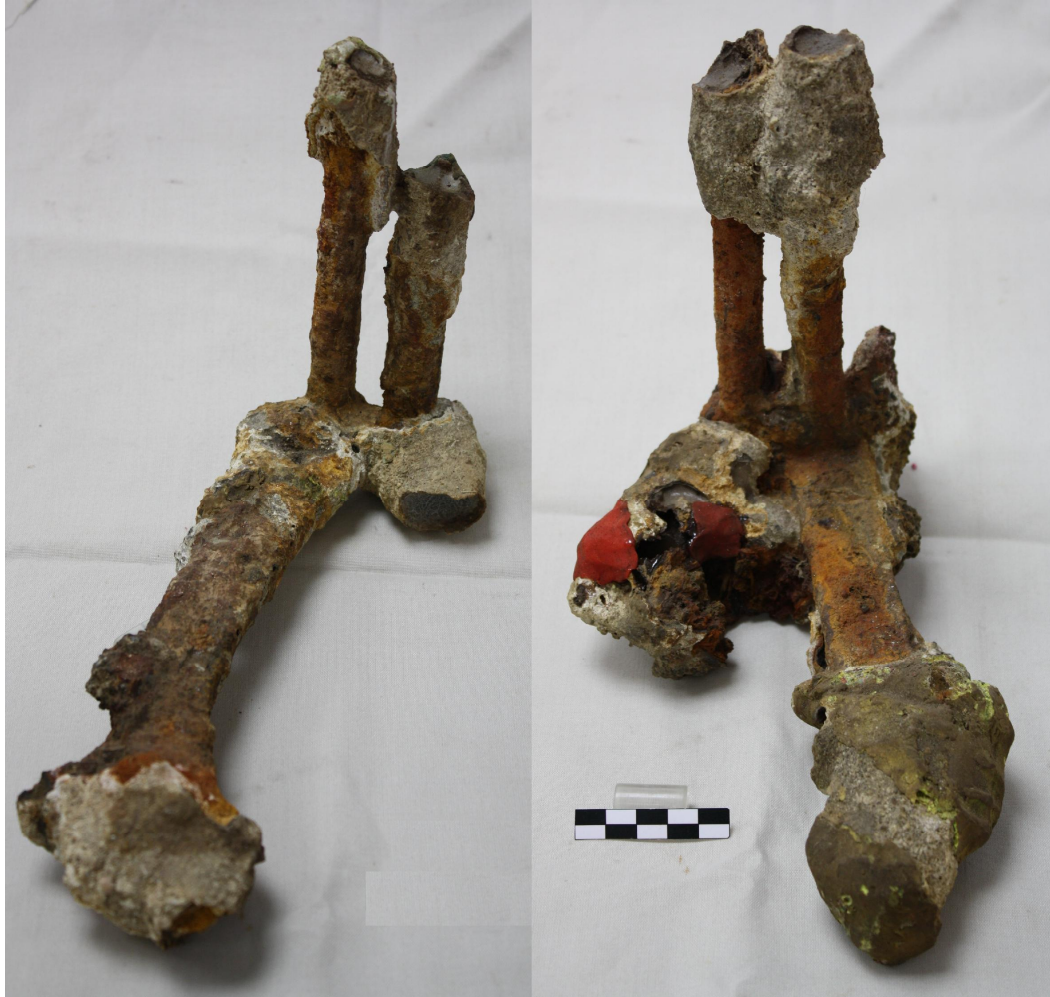
and **UN 2** were cleaned with an air scribe, keeping a portion of the concretion intact at each broken extremity with the hope that other concretions might be identified as being a continuation of the object. There were also organic remains found in the V-shape formed by the lower portion of **UN 1**, and the concretion was kept surrounding them so that samples could be taken and identified. The two objects are identical in shape: the upper portions are formed by two parallel rods, cylindrical in section, and the lower portions are formed by two arms, rectangular in section, at a 90° angle from the rods. The two arms curve toward each other, but it is impossible to say that they were once attached to form a loop, since both are broken and no further connection can be made between **UN 1** and **UN 2** (Fig. 3.19).

Although at this time, the identities of **UN 1** and **UN 2** remain unknown, it can be deduced that the object may have played some role in the galley activities of the ship, given its context among seemingly personal objects of the crew, like the bowl and fishing weight, and within the immediate area another bowl and amphora sherds. It was also in this general area of the excavation that many amphoras were located. One object excavated from the remains of two Roman shipwrecks in Israel shares some of the same characteristics. An iron tripod, constructed of three rectangular bars joined together was uncovered, measuring 15.0 cm in height and 24.0 cm across, and could have been used to hold a pot over an open fire for cooking. The three legs were made of parallel

Fig. 3.19: UN 2 (left) and UN 1 (right) after casting.

One curious detail of the Kızılburun object is that if it represents a tripod, only two of the legs are preserved, and the rectangular arms appear to curve back together, so it is still unclear how UN 1 and UN 2 are truly related. Additionally, the iron rods were

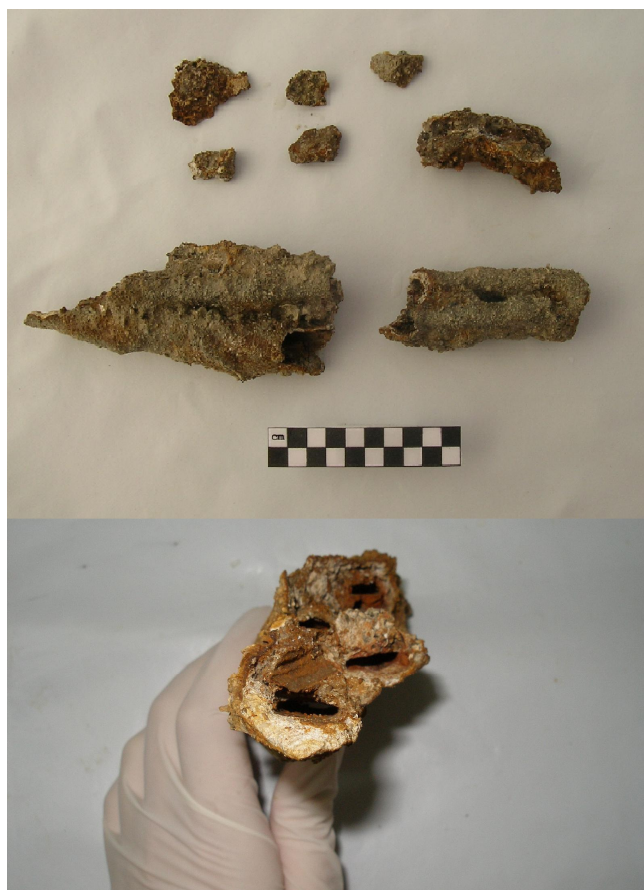
Fig. 3.20: Some of the many fragments of **UN 4**, none of which joined (top), and the cross-section of the largest fragment, showing four separate thin rectangular objects (bottom).

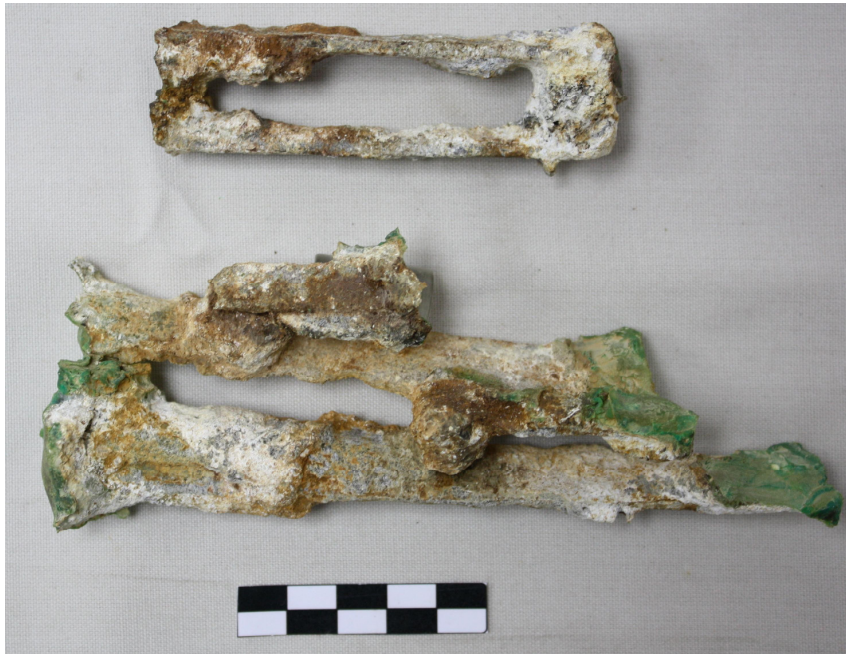
to reconstruct the object (**UN 4**) after it was raised, since it continued to disintegrate upon further handling. Following removal from the seabed, there were two main portions of the concretion that were cleaned and cast. The larger of the two contained four thin, rectangular iron strips, and the smaller seems to be a continuation of it, consisting of two strips lying parallel to each other and connecting at one end (Fig. 3.21). None of the bars has striations to suggest that they are files or rasps. Since none of the four separate objects is complete, it is impossible at this time to identify their purpose. The concretion holding the four pieces together was kept in place in order to retain the spatial relationship between the objects.

Fig. 3.21: **UN 4** after casting.

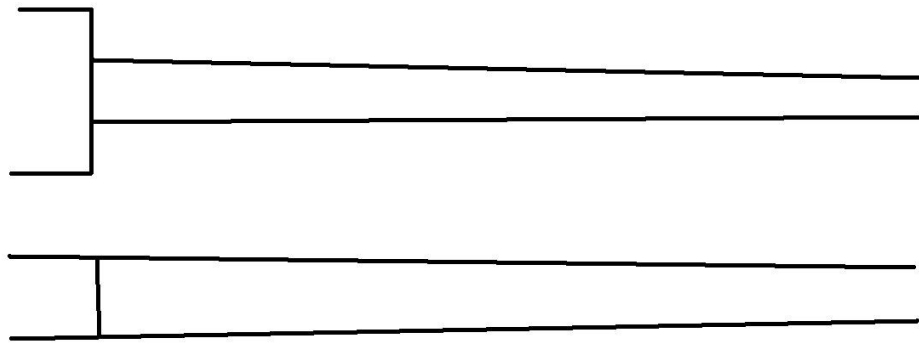
Fig. 3.22: Drawing of UN 5 derived from shape of metal cavity. Original shape of ends is unknown.

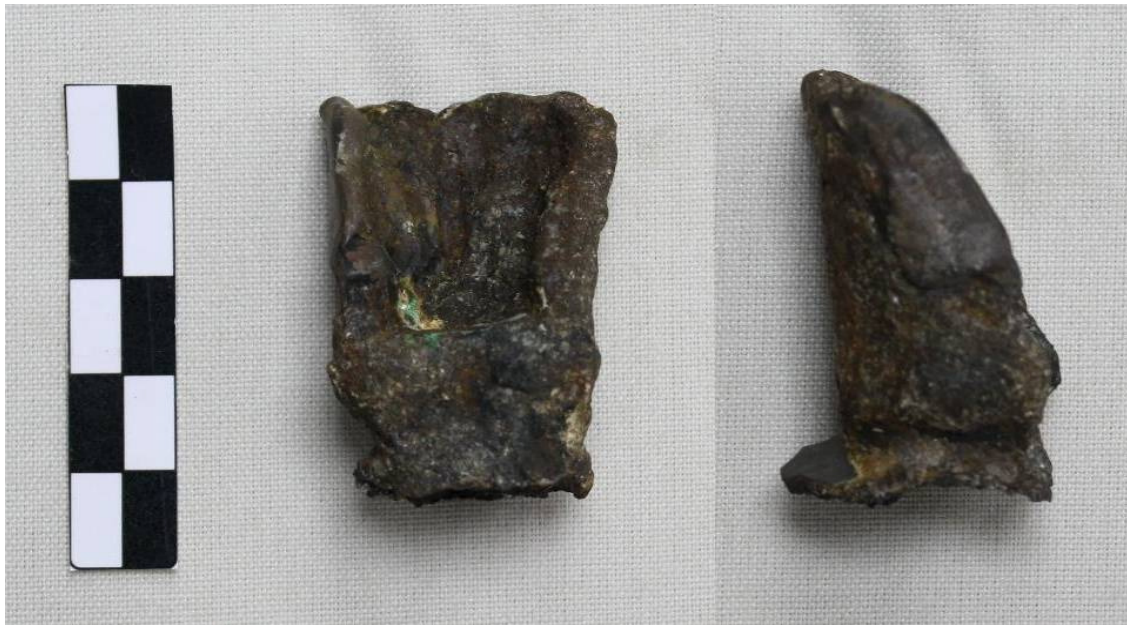
the object appears to have been attached to a cylindrical rod, judging from the change in cross-section. The object flares slightly toward the preserved end, which is flat. Sloping upward from the flattened terminus are two ridges running parallel, growing taller and thus deepening the groove between them, giving it the very rough appearance of a gouge, although no gouges were found to mimic this shape (Fig. 3.23). It was also surmised that this small object might be a wedge or plug used to separate stone slabs in a quarry, but it does not match Rockwell's description of having a V-shaped section, nor is it robust enough to receive a blow from a mallet.<sup>196</sup>

Fig. 3.23: UN 6 after casting.

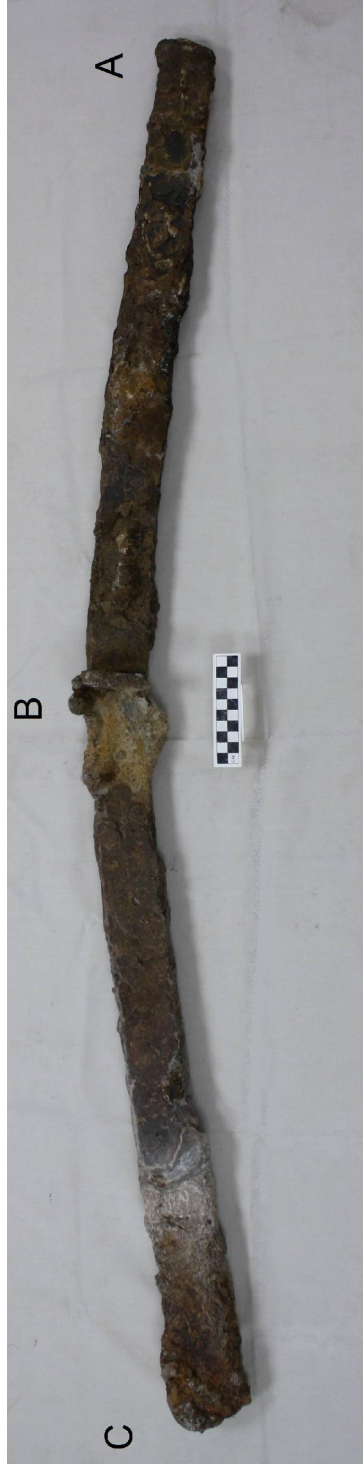
App. 2: **ST 1.**

Although several iron anchors of this type have been described, few have been located with their associated stocks. The Ashkelon anchor stocks, 2<sup>nd</sup> – 1<sup>st</sup> century B.C.E. are similar in style, but they are not an exact parallel. The steps on both stocks are parallel to the stock itself (Galili et al. 2010b), while the step on the Kızılburun stock is perpendicular.

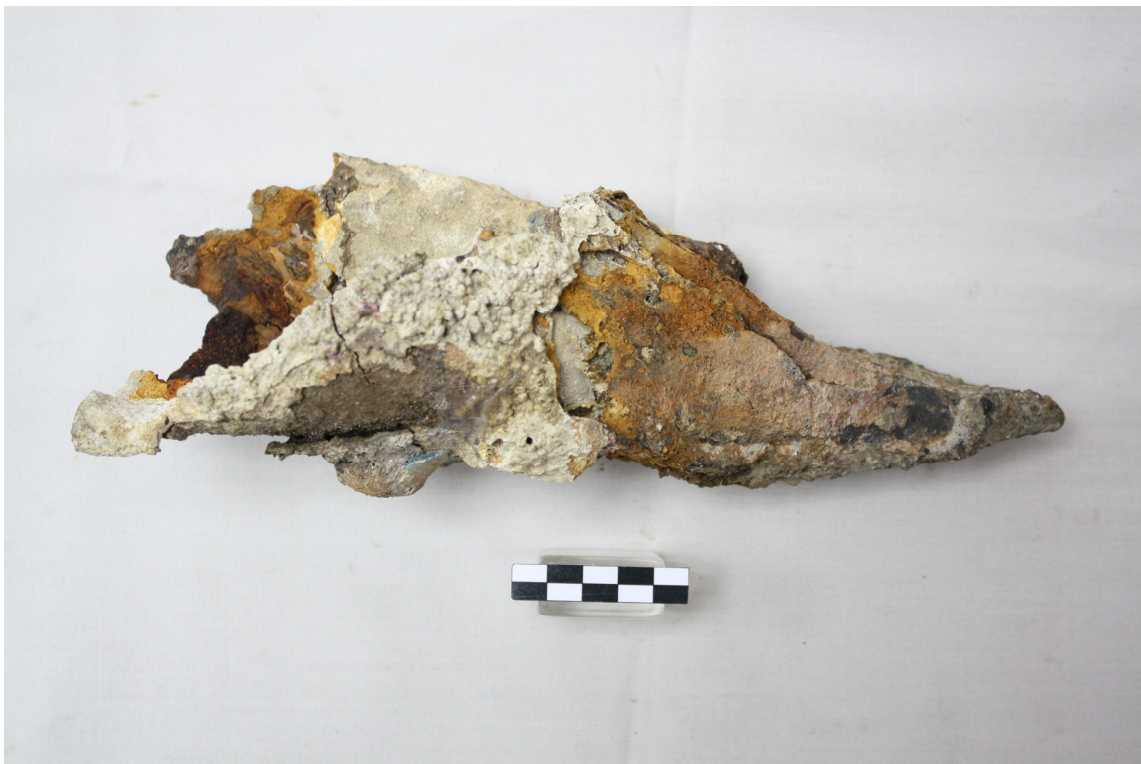
App. 5: AT 1.

**AT 1.** Iron Anchor Tooth (Lot 621)

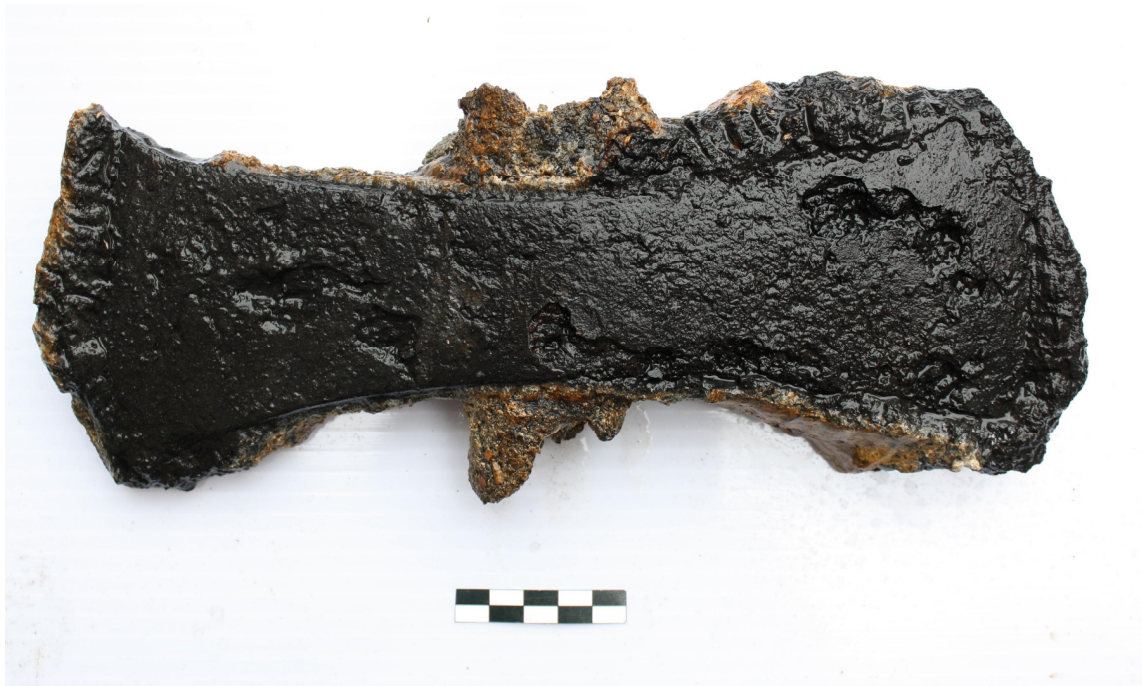
App. 10: **AX 1.**

Two double axes, two shipwrecks, Ashkelon, Israel, 3<sup>rd</sup> - 4<sup>th</sup> cent. C.E. (Galili et al. 2010a).

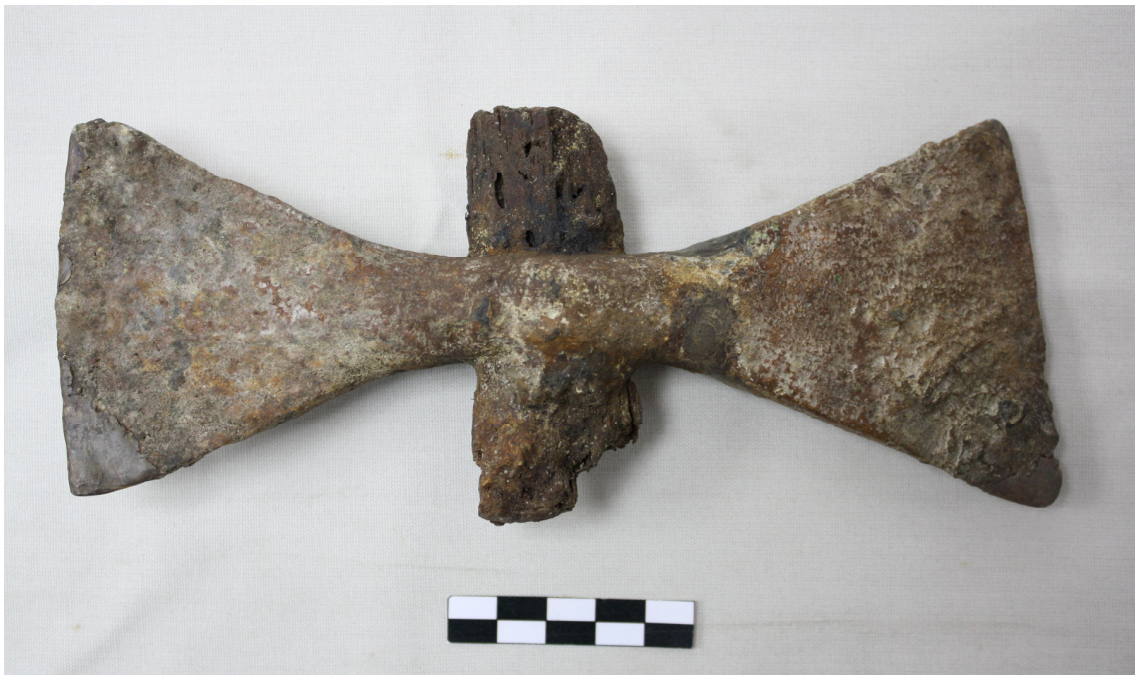
App. 11: **AX 2.**

**AX 2.** Iron Double Axe (Lot 824)

Resembles more modern type of axe. Archaeological parallel not found.

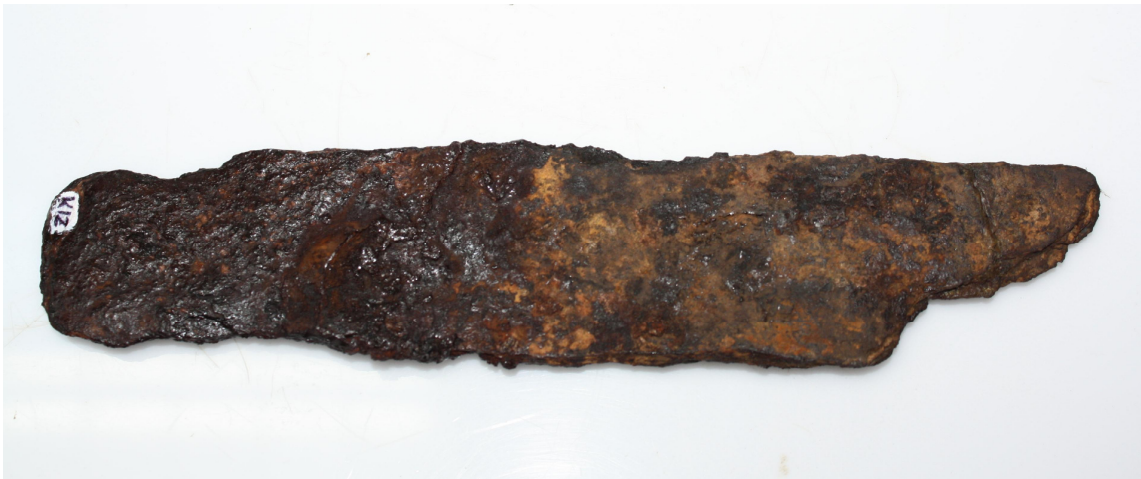
App. 12: **FB 1.**

**FB 1.** Iron Bar (Lot 387.01)

Closest parallel: Single iron bar, Cap del Vol shipwreck, Spain, 1<sup>st</sup> cent. B.C.E. (Foerster 1980).

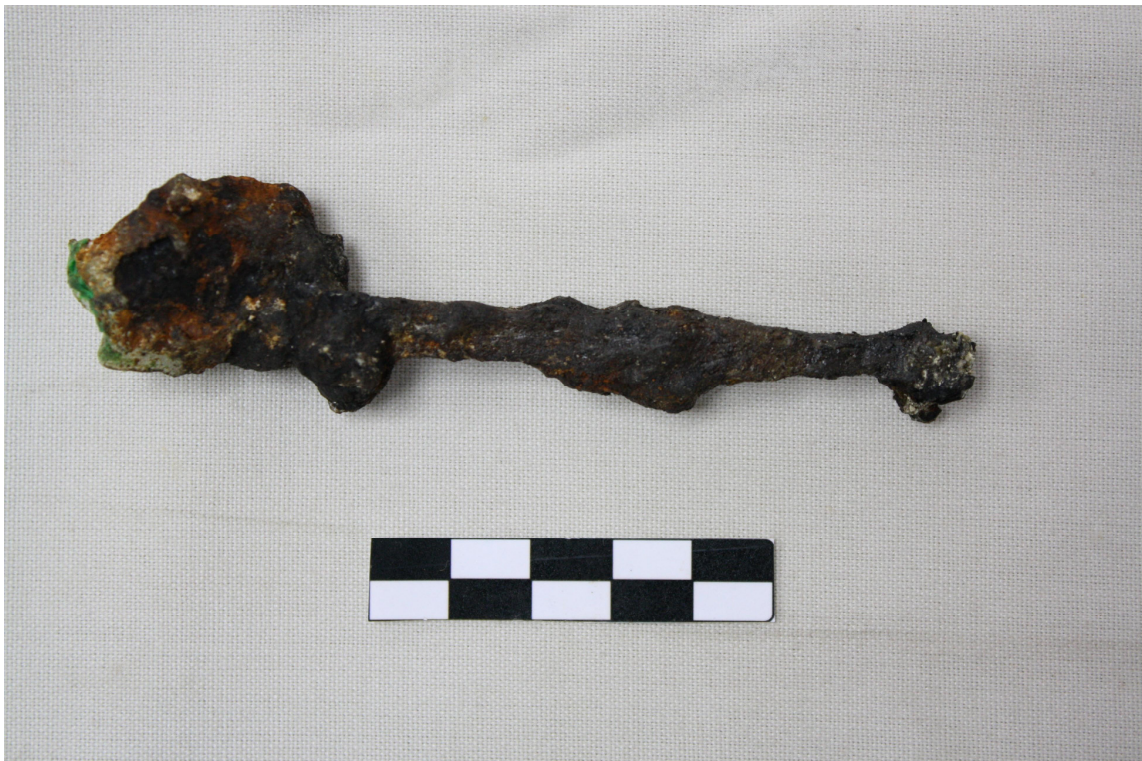
App. 13: **FN 1.**

**FN 1.** Iron Nail (Lot 144)

Square section nails common and found throughout Roman provinces.

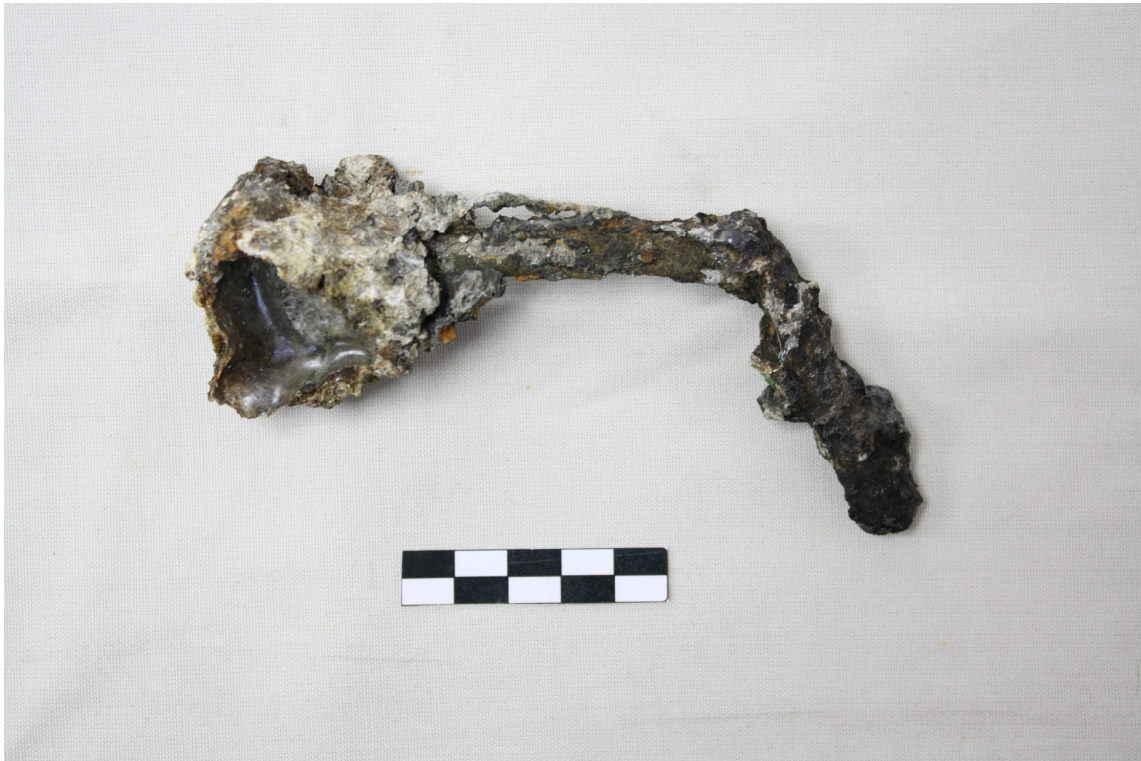
App. 14: **FN 2.**

**FN 2.** Iron Nail (Lot 655.04)

Square section nails common and found throughout Roman provinces.

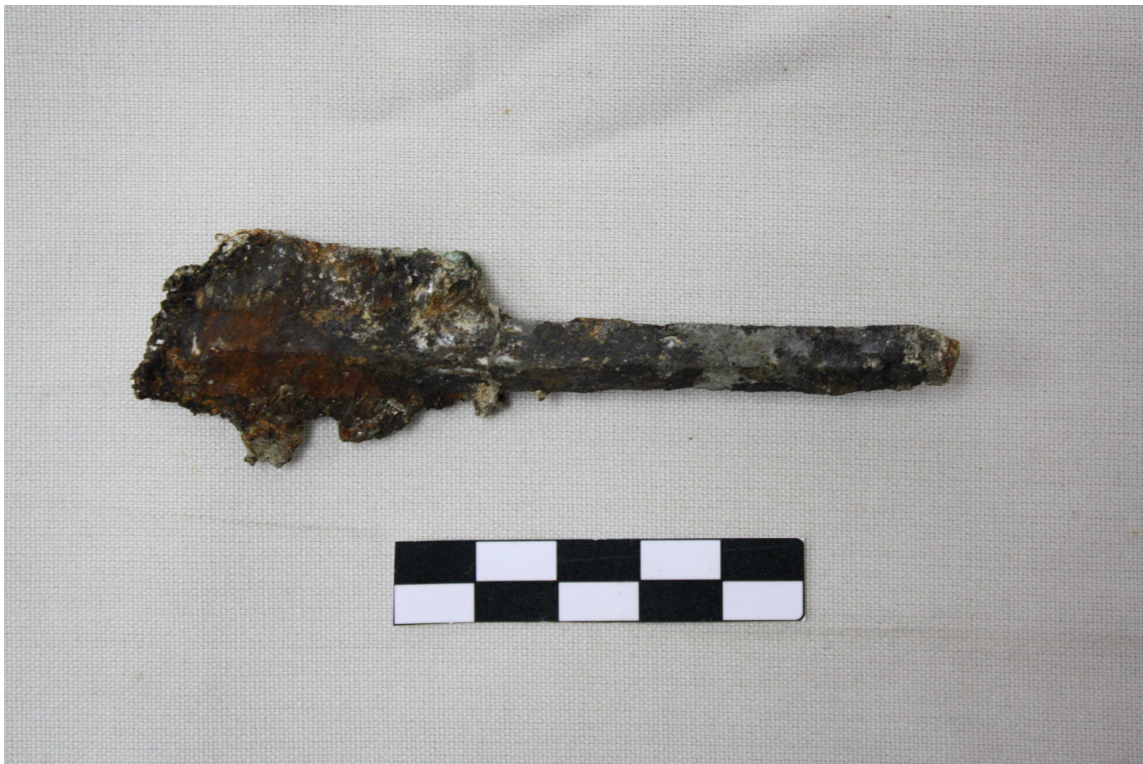
App. 15: **FN 3.**

**FN 3. Iron Nail (Lot 950)**

Square section nails common and found throughout Roman provinces.

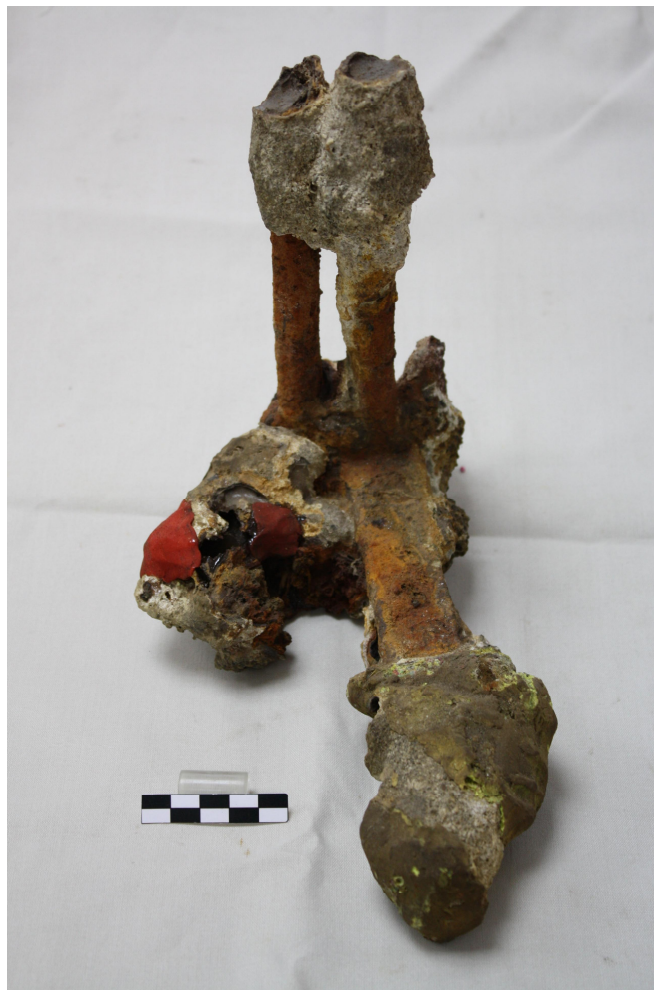
App. 16: **UN 1.**

**UN 1. Unidentified Iron Object (Lot 152)**

No exact parallels found. Somewhat resembles iron tripod from two Roman shipwrecks, Israel, 3<sup>rd</sup> – 4<sup>th</sup> centuries C.E. (Galili et al. 2010a), but rectangular bars would not join to form triangle.

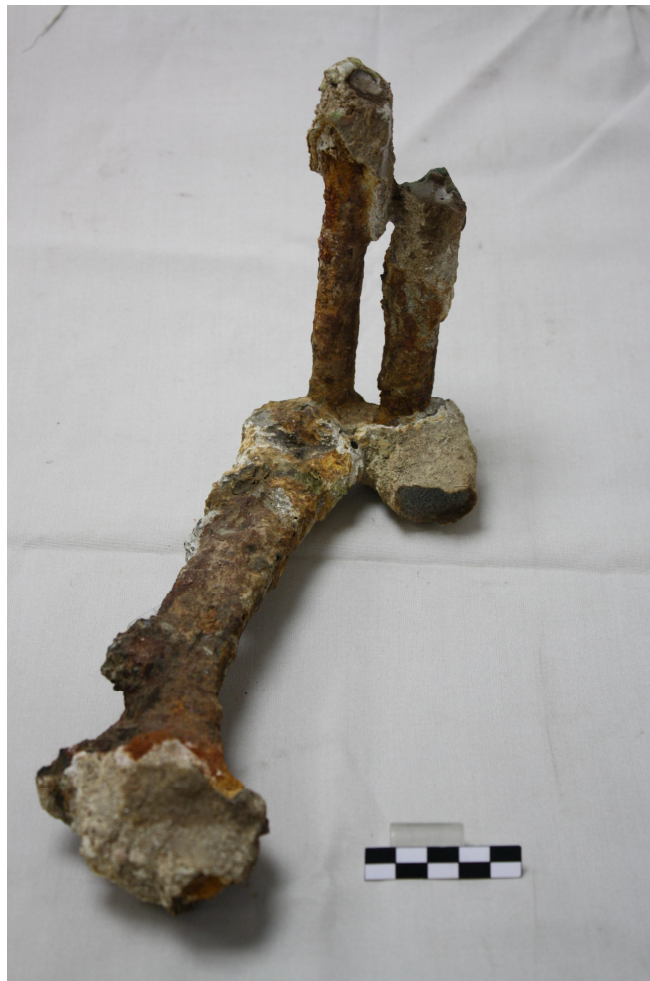
App. 17: **UN 2.**

**UN 2.** Unidentified Iron Object (Lots 177 and 177.01)

No exact parallels found. Somewhat resembles iron tripod from two Roman shipwrecks, Israel, 3<sup>rd</sup> – 4<sup>th</sup> centuries C.E. (Galili et al. 2010a), but rectangular bars would not join to form triangle.

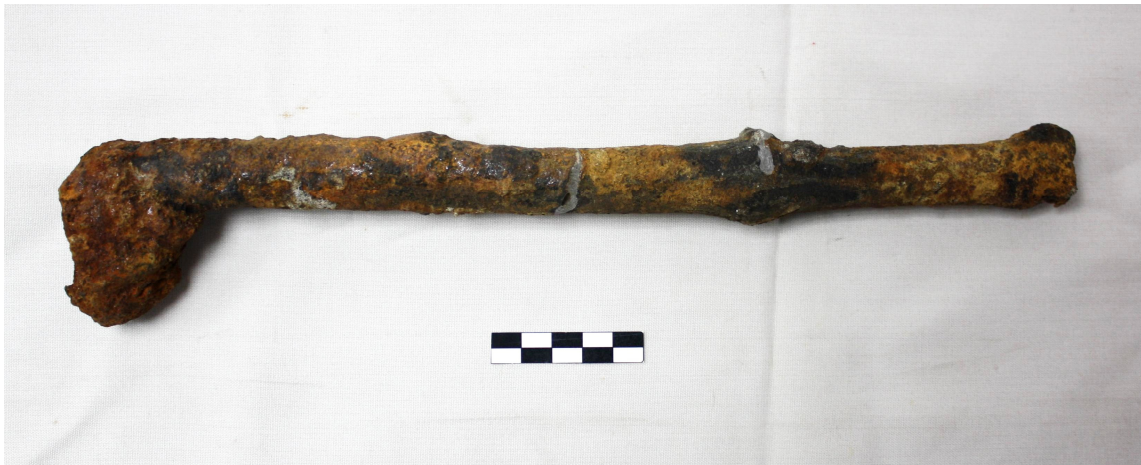
App. 18: **UN 3.**

**UN 3. Unidentified Iron Object (Lots 396 and 497)**

Two separate concretions (Lots 396 and 497) that join were found in two separate seasons. Since the concretion was broken, the internal cavities were full of sand, and the original surface of the object was not well-preserved. The cast produced is an iron rod (**UN 3**) with a cylindrical cross-section, perhaps a type of large iron fastener, such as a bolt, but because the extremities of the cast are misshapen, it is not possible to say definitively. There are also no wood remains attached to it, as is usually found with fasteners. Bolts were introduced as a means to reinforce the hull by fastening the frames to the keel during the Hellenistic era and became common practice by the 2<sup>nd</sup> century C.E., as evidenced by several shipwrecks of that century and later. At first bolts were

made of copper, and it was not until the 4<sup>th</sup> century C.E., that copper was replaced almost entirely by iron;<sup>194</sup> therefore it is unlikely that **UN 3** is an iron bolt.

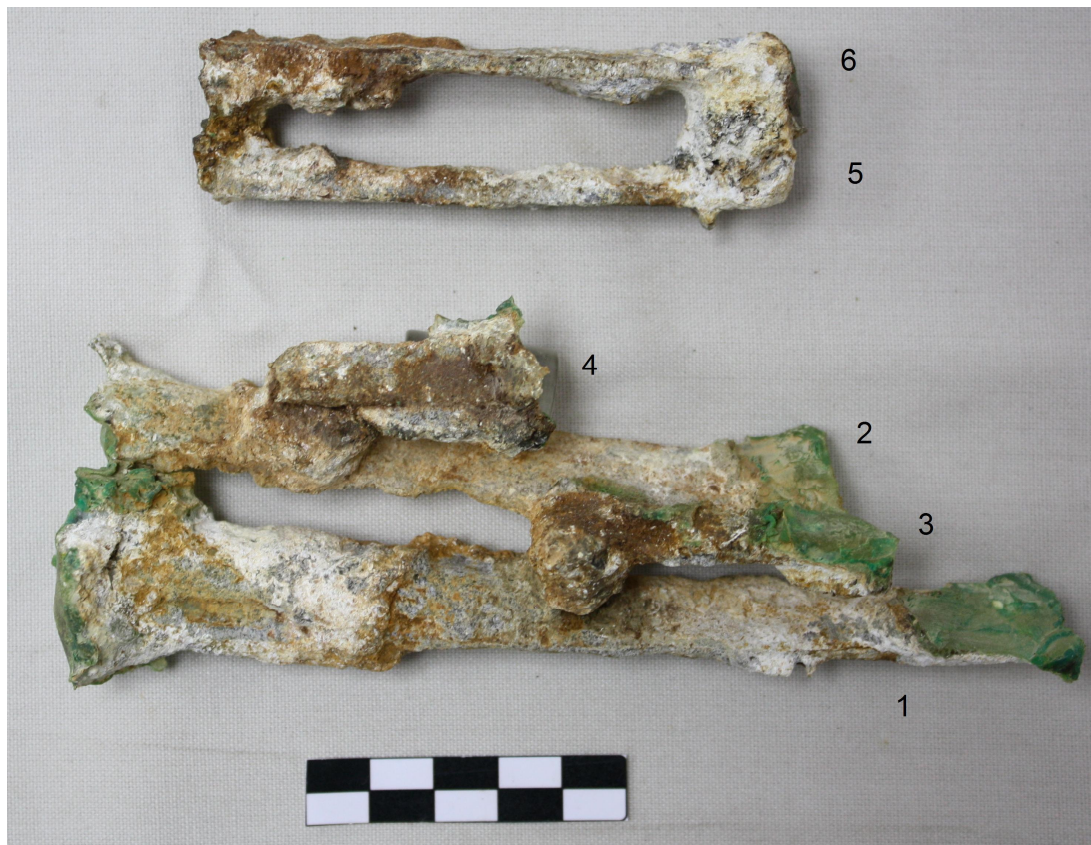
App. 19: UN 4.

**UN 4. Unidentified Iron Object (Lot 618)**

No known parallels found. Somewhat resemble files, but no serrations.

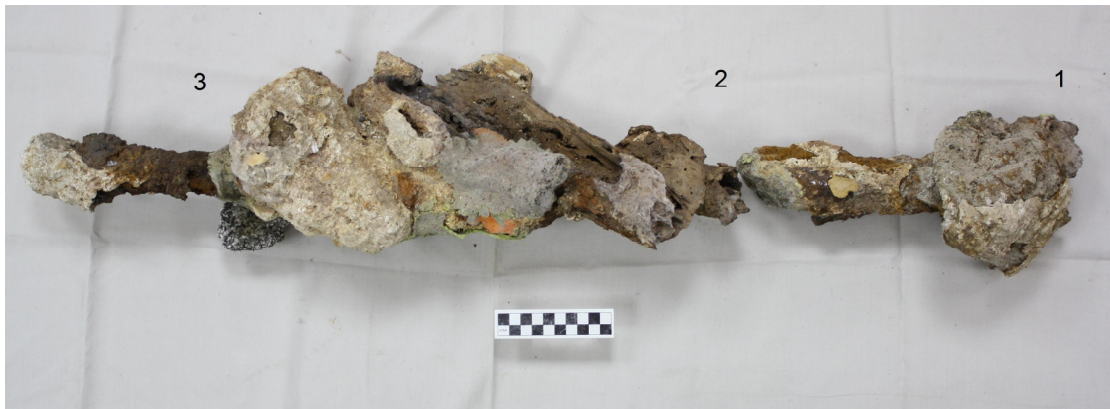
**UN 5.** Unidentified Iron Object (Lots 605, 713, and 733)

App. 20: **UN 5** – Concretion (top) and shape determined by inner cavities (bottom).

Three large concretions unearthed in 2007 form one continuous shank-like object (UN 5) measuring 94.5 cm in length. Lot 733 forms one end of the object, Lot 713 the central section, and Lot 605 the other end, at which point the concretion is broken. The object has a squared cross-section throughout Lots 733 and 713, measuring approximately 3.0 cm by 3.5 cm, but at the very end of Lot 605, it flares to a wider section measuring 5.3 cm by 3.5 cm (Fig. 3.22). The object is definitely not a second iron anchor, and given the attributes that can be distinguished, it is not an anchor stock. There are substantial wood remains, closely resembling planking, attached to the middle section, but no copper nails were visible, and there are two large amphora body sherds concreted to it.

Recently, similarly shaped concretions were found on the Levanzo I shipwreck near Sicily. Dating to the 4<sup>th</sup> century C.E. due to the amphoras found at the wreck site, this ship carried two large iron bar concretions, one of which was raised. The preserved length measured approximately 1.5 m and the cross-section varied from 4.9 cm by 2.1 cm to 7.6 cm by 3.4 cm.<sup>195</sup> The authors compare the Levanzo I bars to iron ingots found on other shipwrecks; however, I am disinclined to agree with this assessment, given that the bar concretion also has an associated link chain preserved within it. Once the concretion from the Levanzo I shipwreck is cast, its purpose may be revealed, which may in turn provide an identity for the large Kızılburun concretion.
